The following statistical analysis and evaluation was performed through 2024, fulfilling Illinois statute requirements governing Automated Photo Enforcement and reporting requirements for IDOT permitting at the intersections listed below.

After finding limited success with other attempted measures to promote safer driving and improve compliance with traffic laws, Red Light Running (RLR) Photo Enforcement System(s) were installed at the following intersection(s):

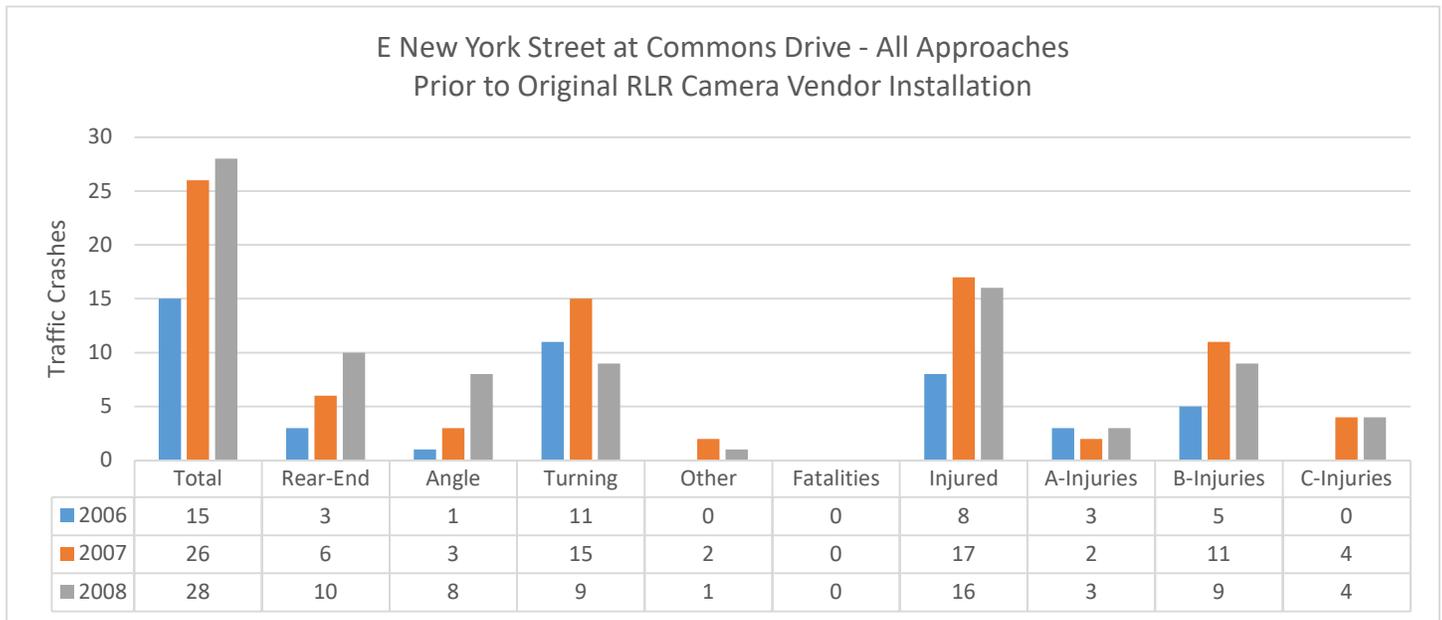
Graph 1

Crash data is obtained from the Illinois Department of Transportation (IDOT), specific to the RLR camera location(s) for the 3-year period prior to camera installation (Graph 1, 3) and the most recent 3-years of IDOT published data (Graph 2, 4) or post camera installation.

E New York Street at Commons Drive

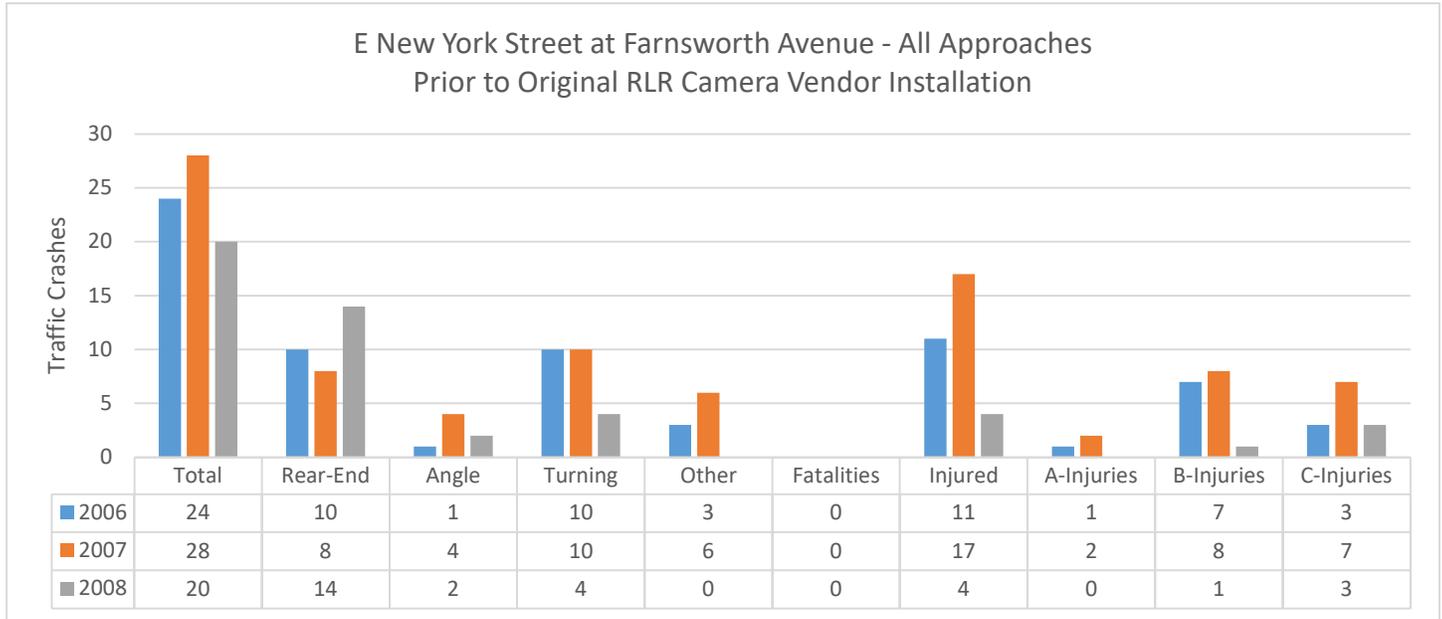
Graph 1

E New York Street at N Farnsworth Avenue

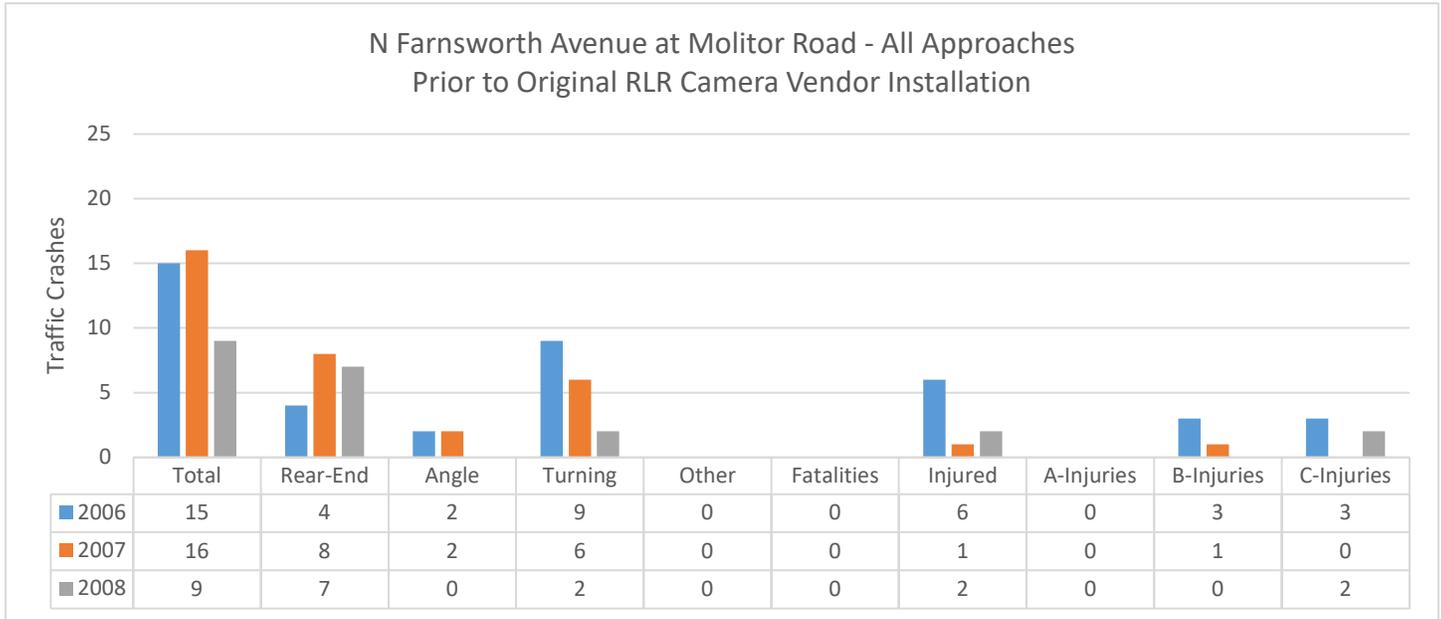
Graph 1

N Farnsworth Avenue at Molitor Road

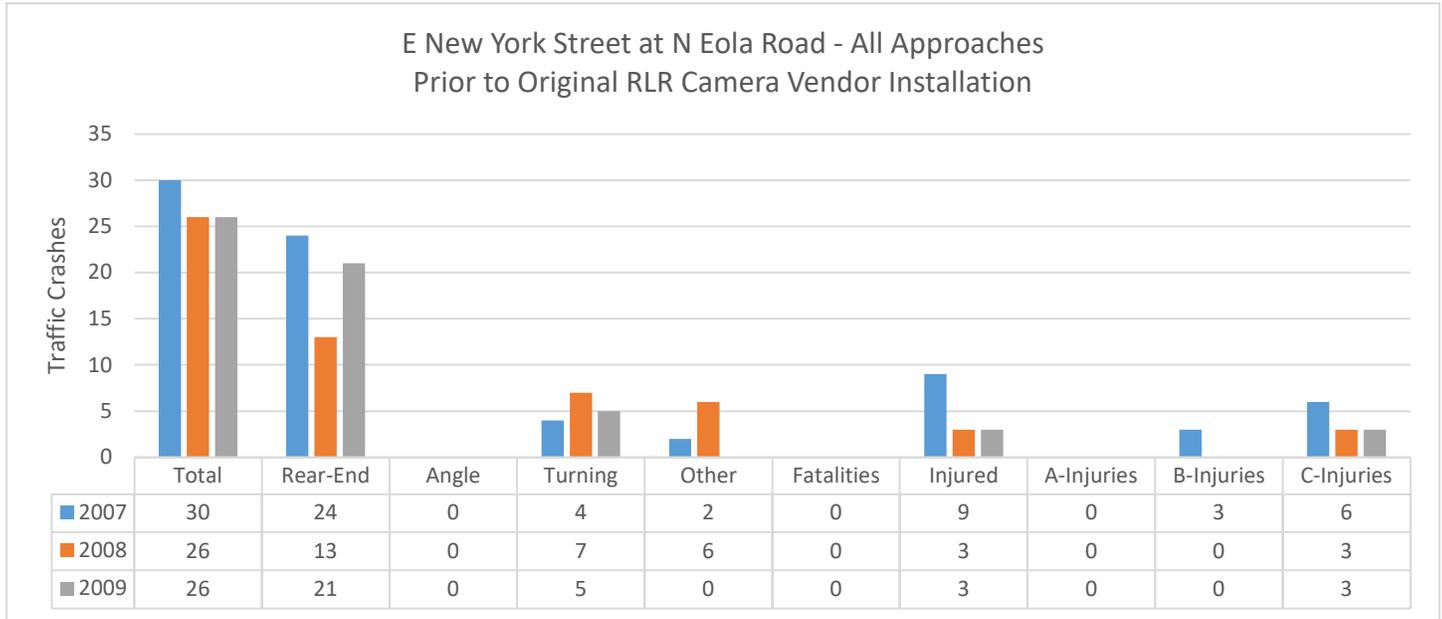
Graph 1

E New York Street at N Eola Road

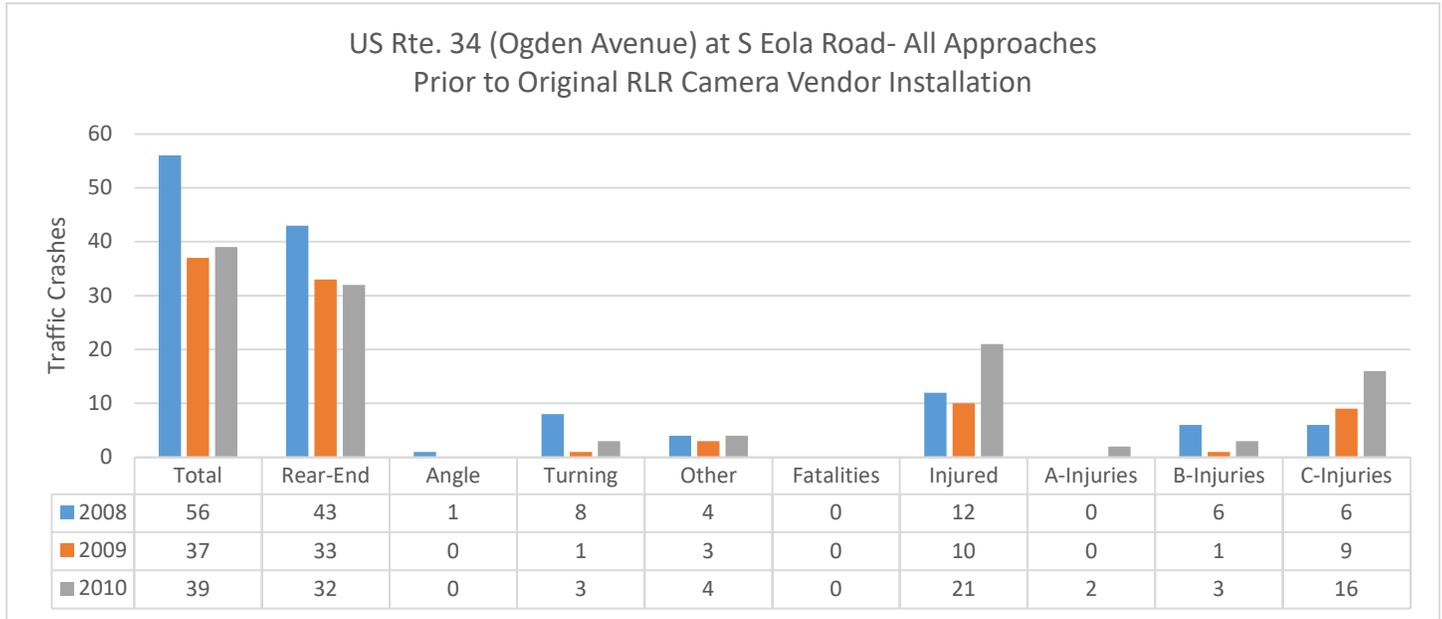
Graph 1

US Rte. 34 (Ogden Avenue) at Eola Road
